**HOTEL FIRE**  
Paterson, NJ  
October 18, 1984

**NATIONAL FIRE PROTECTION ASSOCIATION**

Investigation Report  
Alexander Hamilton Hotel Fire  
Paterson, New Jersey  
October 18, 1984

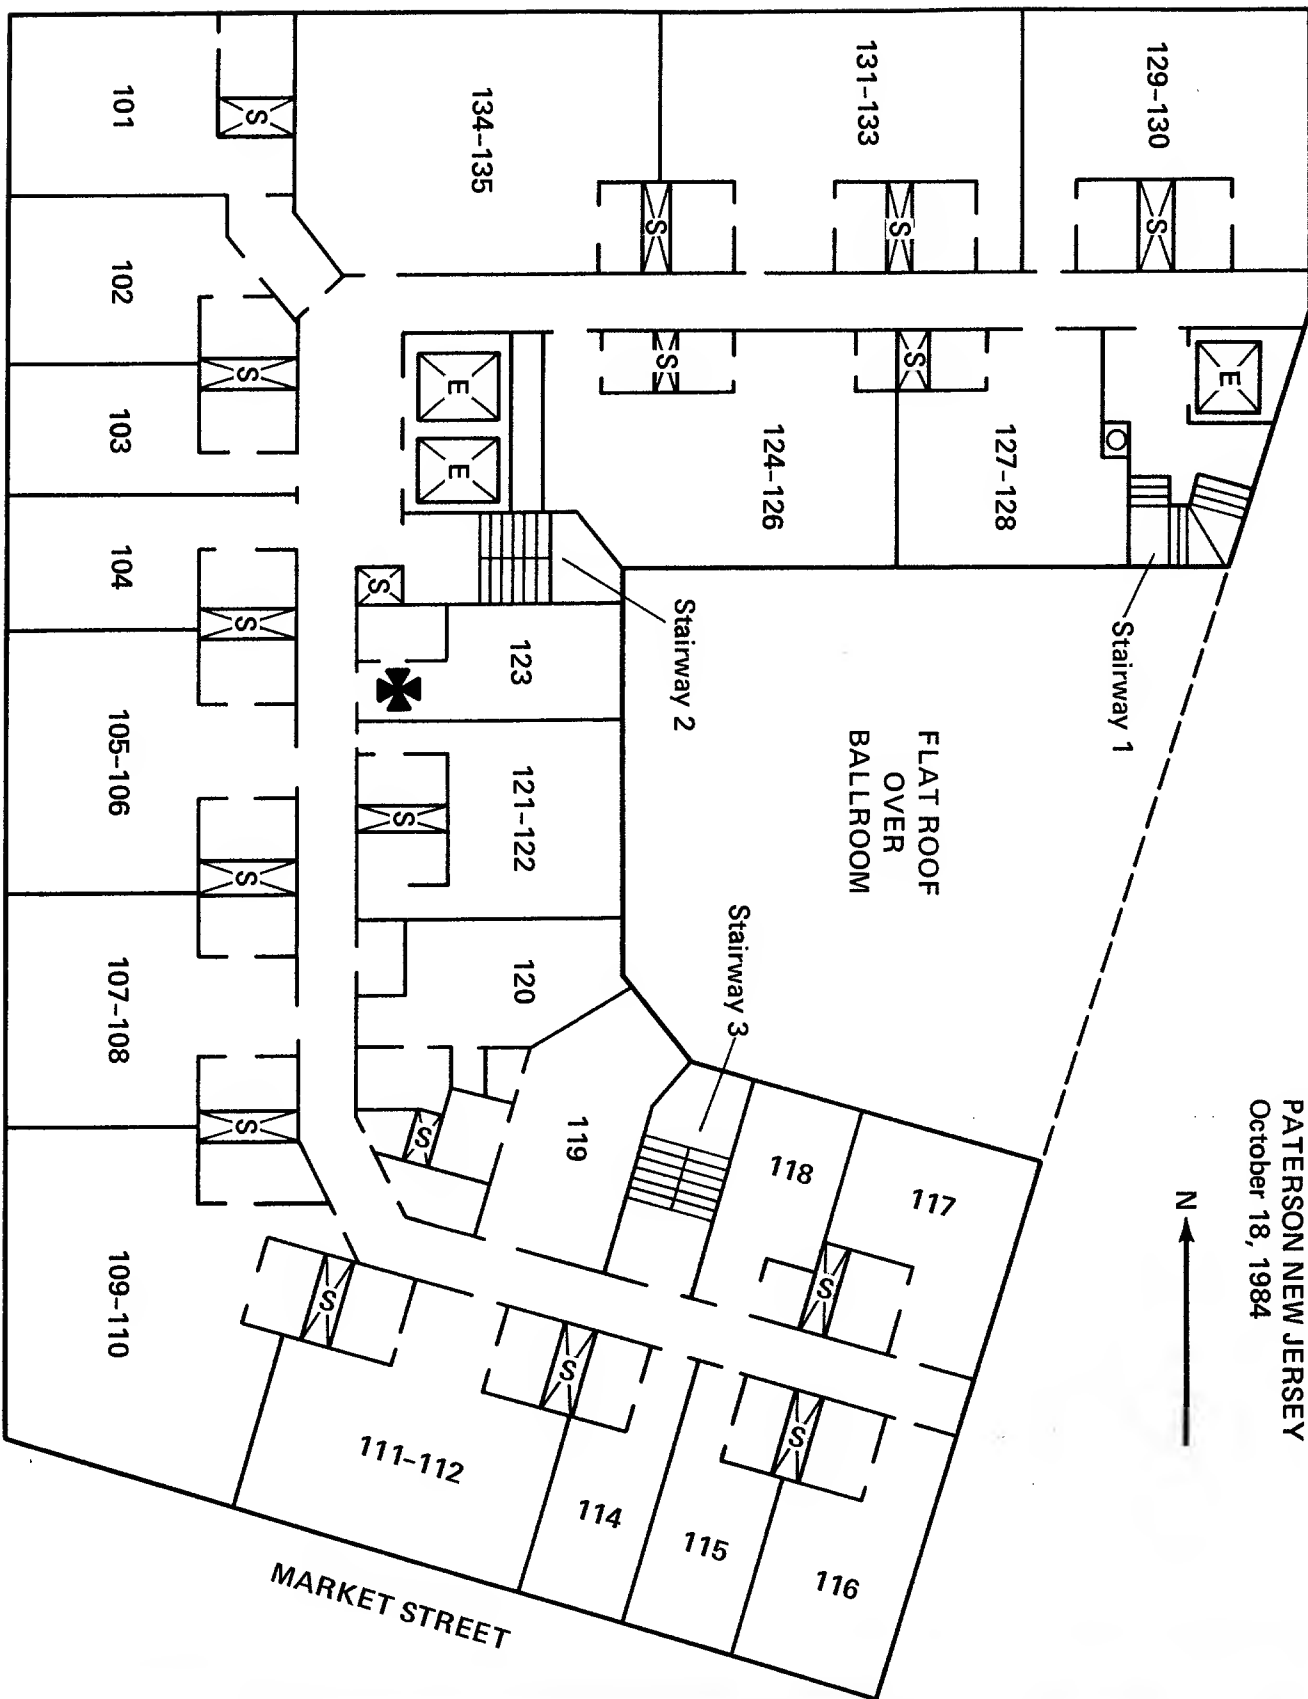
ALEXANDER HAMILTON HOTEL  
PATERSON NEW JERSEY  
October 18, 1984

The fire by this time was gaining headway, due to air entering through the open window, and it quickly began to expose the corridor. As the fire spread into the corridor, the wood paneling and combustible ceiling tile provided fuel which contributed to fire development.

The hotel used 55-gallon steel drums for the collection of rubbish. A drum was located in the stairways at each floor level. These drums were often used to block open stairway doors as the corridors were dimly lit. On the night of the fire, the central stairway, (No. 2) which was adjacent to the room of origin, had the door blocked open by a drum. Also the door to stairway No. 1 did not close.

As the fire developed on the third floor, it extended into a number of rooms. This allowed smoke to penetrate the bathroom ventilation shafts. The smoke then spread into other rooms on upper floors from these shafts and also banked down from the plenum into the other shafts and from there into bathrooms.
